**ORLEANS PARISH
DRAINAGE PUMPING STATIONS**

KATRINA DAMAGE REPAIR

**U. S. ARMY CORPS OF ENGINEERS
NEW ORLEANS DISTRICT**

February 15, 2006

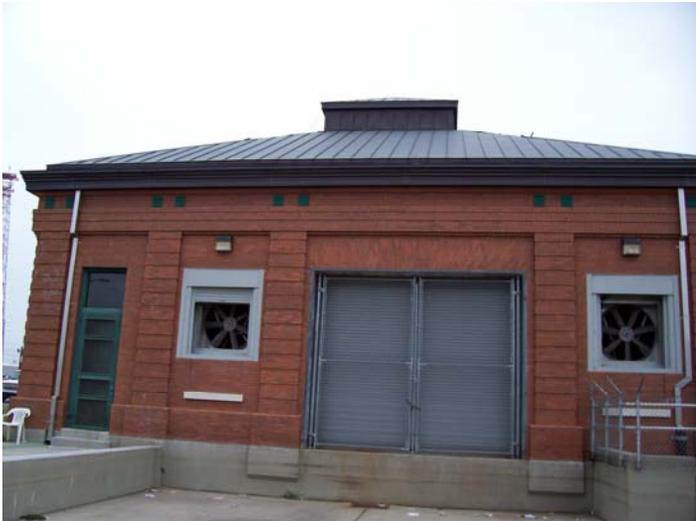
Photo 1 – Roof ridge flashing missing; west end of bldg.

1. The flood water level in the station was 11 inches above the operating floor, and 5 inches above the control room floor.
2. Replace roof ridge line flashing missing on SE and SW end of building (about 10' each). There is evidence of roof leaks on the west end of the building. Repair roof as necessary.
3. The 7' X 14' wooden roll-up door on the north end of the building is broken off the rail. Recommend repair of the wooden doors.
4. Replace control room vinyl floor tiles and wood paneling (15' X 15' X 8'). Replace wood paneling on the outside of the control room.

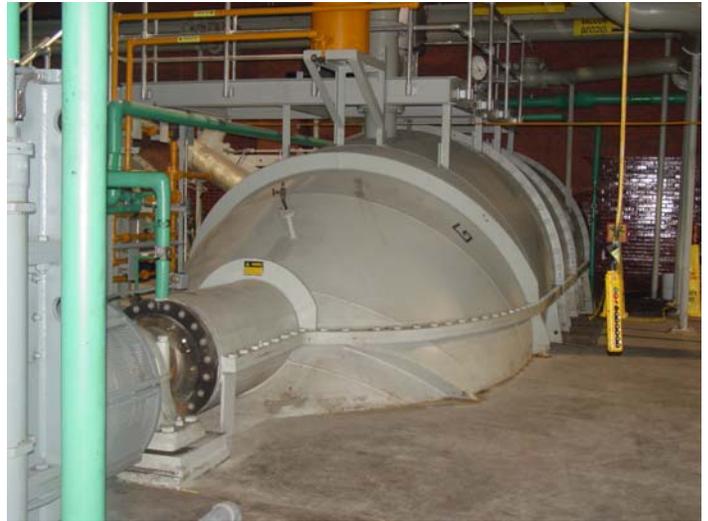
Photo 2 – Pump G

1. Inspect and replace the inboard bearings for Pumps G and F.

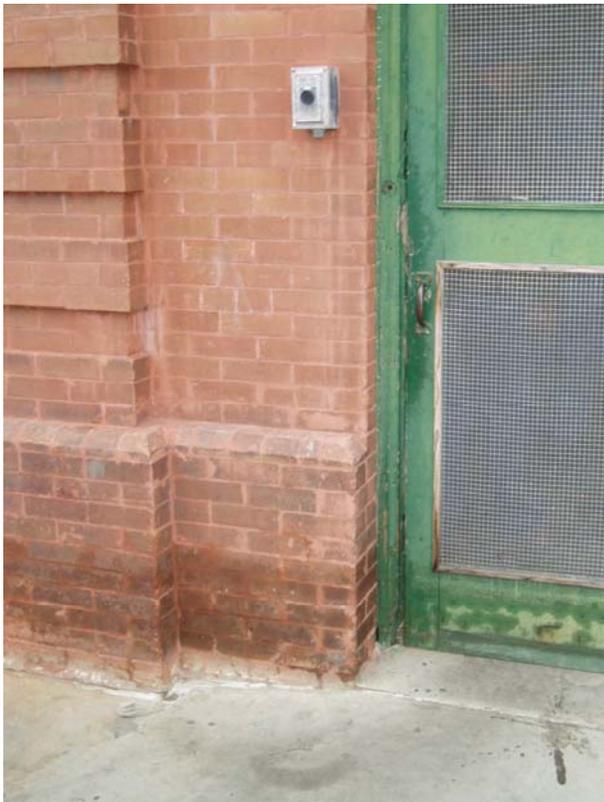
Photo 3 – Water mark on station bldg.

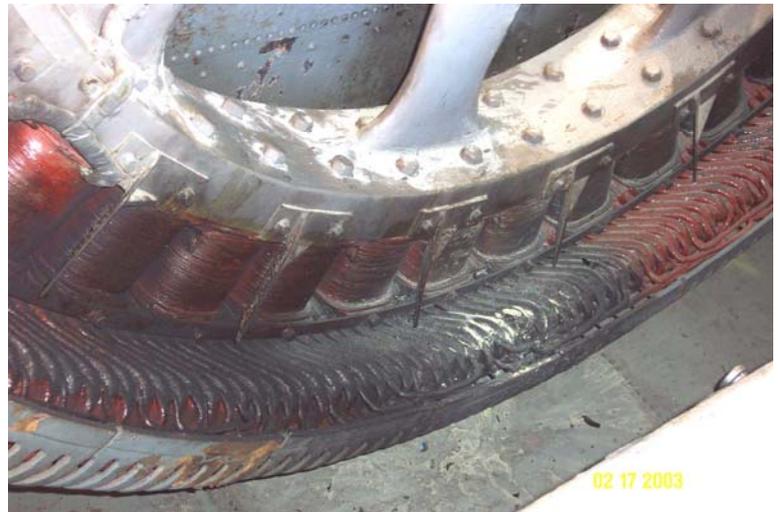
1. Pump motors for drainage pumps A, B, C, D and E were cleaned and baked. Because the motors sustained damage from being submerged in the hurricane, this procedure doesn't guarantee they will continue to work when needed. In fact, the motor for Pump A had been baked and had selected poles repaired, but it failed the first time it was energized and loaded. Therefore, it is recommended that the stators and poles for the rotors be rewound for the motors for Pumps B, C, D, and E. (The S&WB is currently rewinding the stators and rotors for Pump A motor.)

Photo 4 – Burned motor for Pump A.

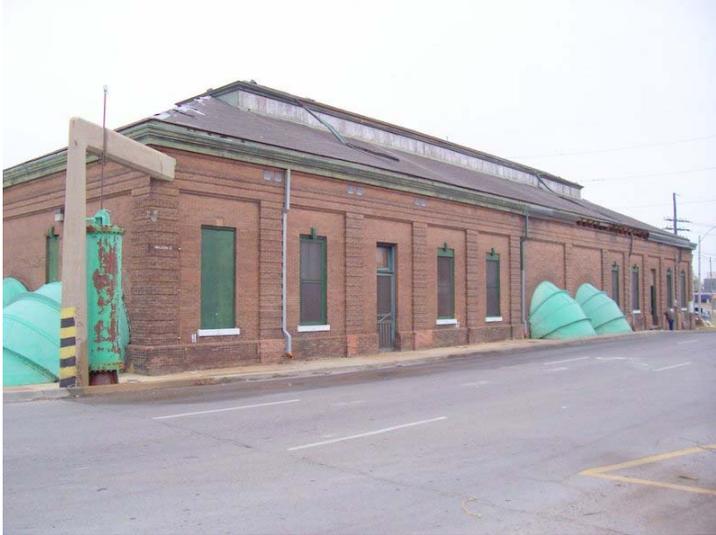
- a. Approximately 160' of copper gutter along the center gable on the east side was damaged or missing,
 - b. Approximately 170' of copper fascia on the east side was missing,

- c. The entire shingle roof is in poor condition and should be replaced with a metal roof.
3. The storage building, measuring 25' x 25', was flooded 11" above the floor and needs cleaning out. About 50' of the clay ridge tiles on the roof were blown off. The entire building should be replaced or demolished. (Recommend demolition of the building; S&WB does not need building.)

Photo 1 – Roof damage to station bldg.

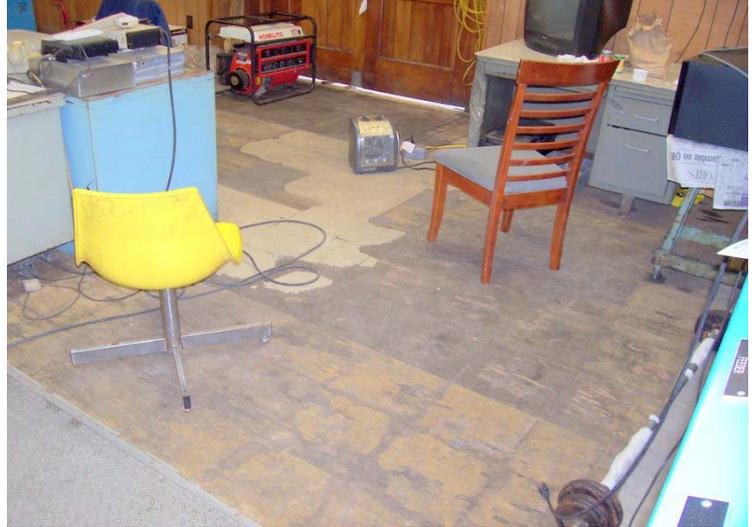
4. The vinyl tile flooring, and the wood sub-floor, in the control room was damaged. The estimated area is 550 square feet. Recommend replacement.
5. The lag bolts, which attach the roof to the steel purlins, are missing in the NE area of the roof, directly over Constant Duty Pumps Nos. 2 and 3. These should be replaced.

Photo 2 – Damage to control room floor.

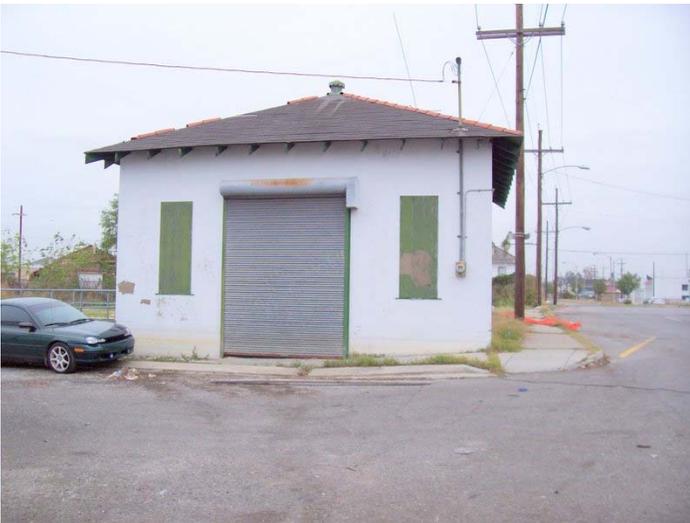
Photo 3 – Storage bldg. to be demolished.

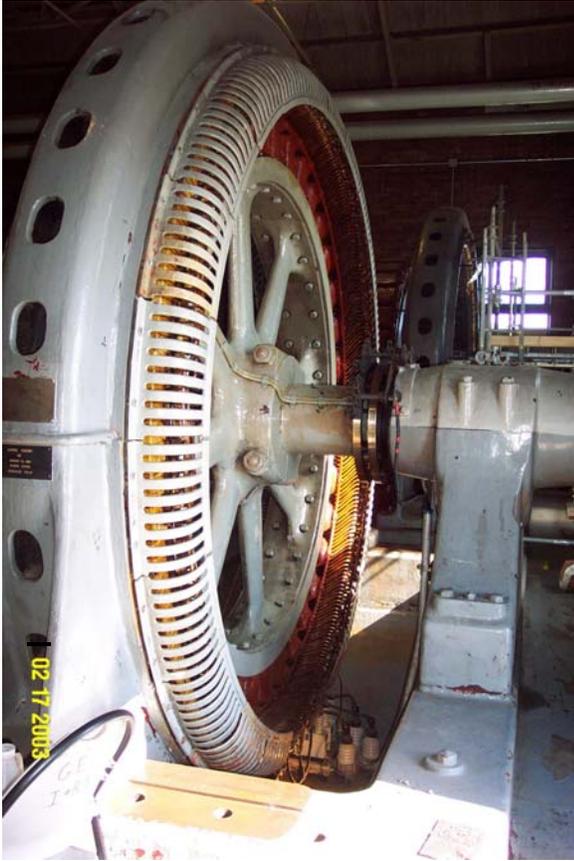
Photo 1 – Motor to be rewound.

1. Pump motors for drainage pumps A,B,C, D, and E were cleaned and baked. It is recommended that the motors for these 5 pumps have the stators and coils rewound due to having been submerged. (See Electrical description for Station No. 1)
2. Re-support cable trays.

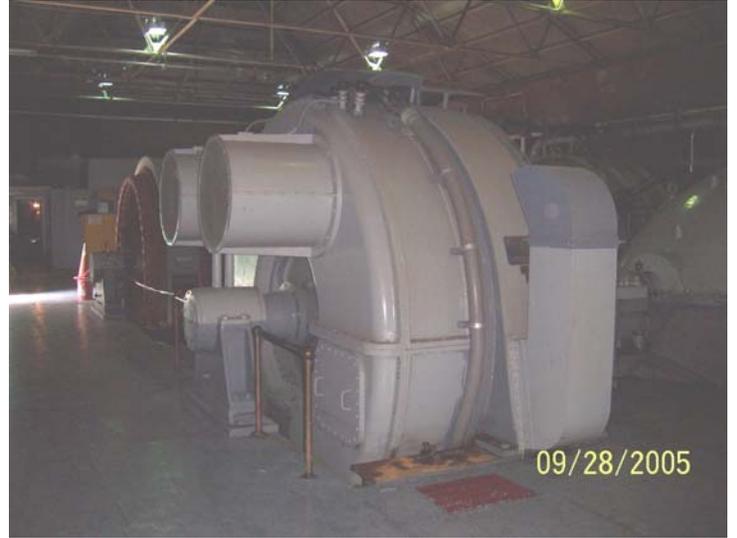
Photo 2 – Pump D protective shroud to be removed.

1. Remove protective shroud and inspect Pump D; match and mark all pieces and fasteners and place shroud back together as waterproof. Repair or replace defective pump components as required.

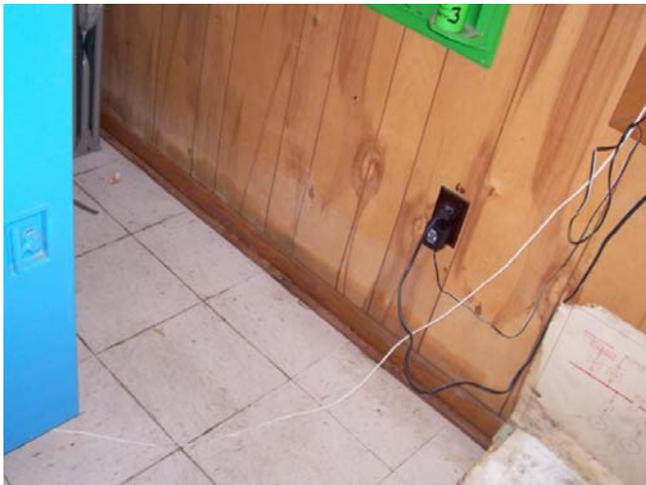
Photo 3 – Damaged floor and wall in control room.

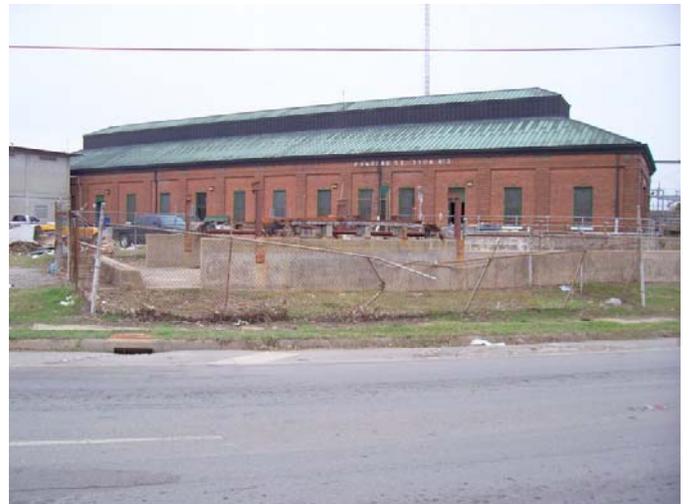
Photo 4 – Damaged fence.

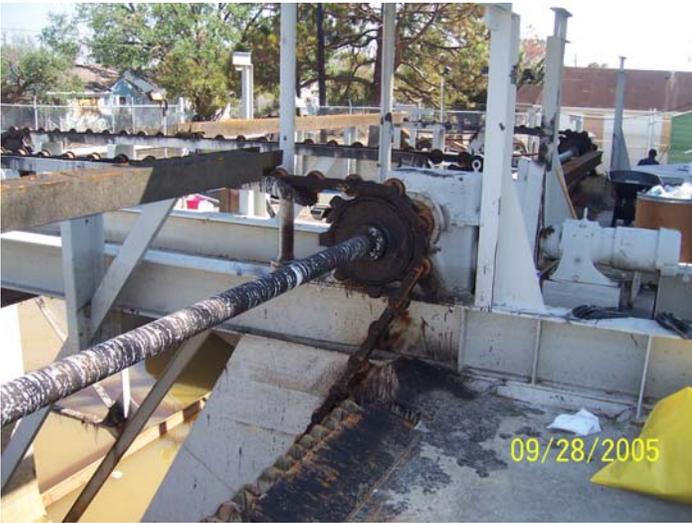
Photo 1 – Trash Racks.

1. The inboard bearings on Pumps C, D, and E should be replaced.
2. The motors for the trash racks should be rewound and the gear boxes replaced (25 cycle).
3. Minor repairs are required to the piping and valves for the cooling water system.

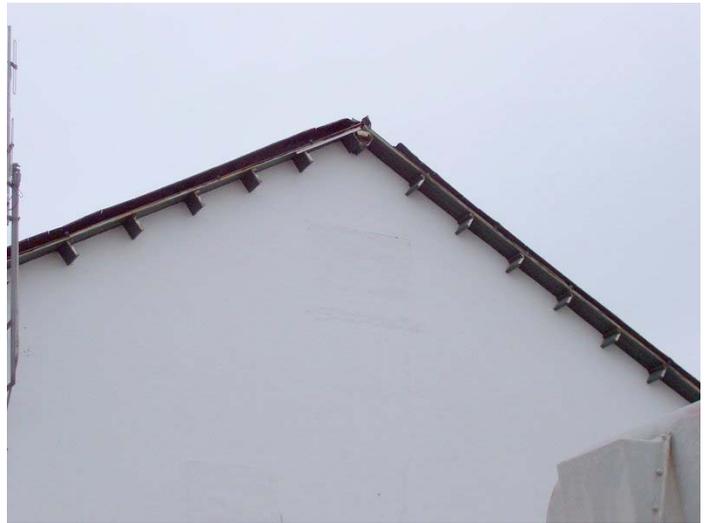
Photo 2 – Damaged roof.

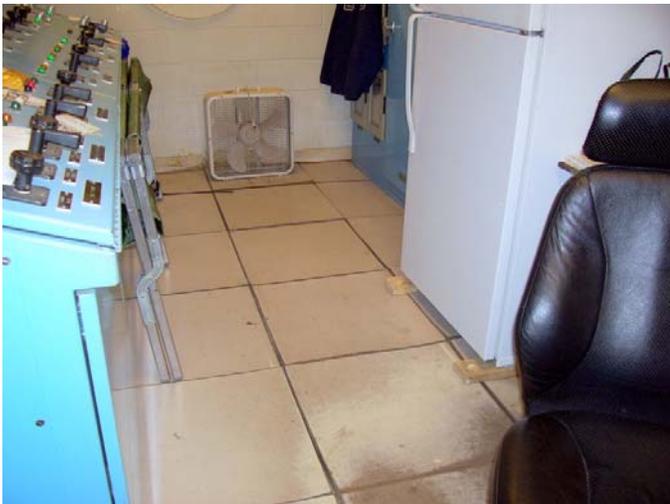
Photo 3 – Damaged tiles in control room.

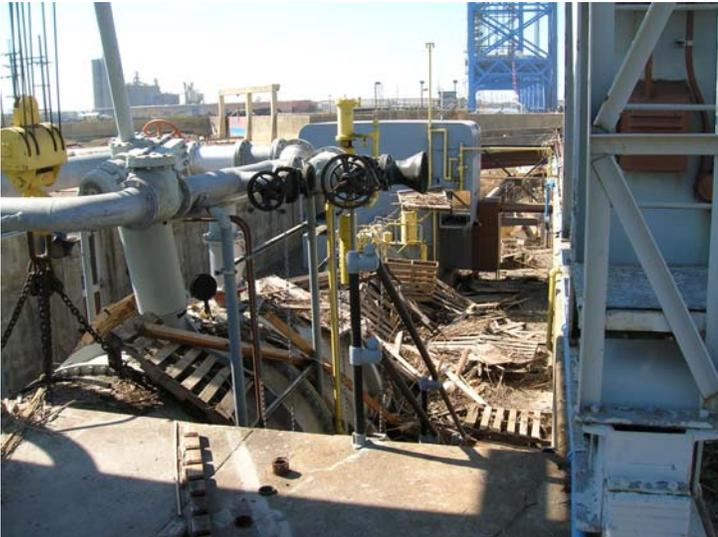
Photo 1 – Pump D.

1. Replace entire fuel system due to being completely flooded.
2. Replace inboard bearings for Pump D.
3. Rewind motor and replace gear box for the trash racks on the Jordan Ave. side of the station.
4. Miscellaneous cabinets, water cooler, refrigerator, etc., need to be replaced due to being submerged.

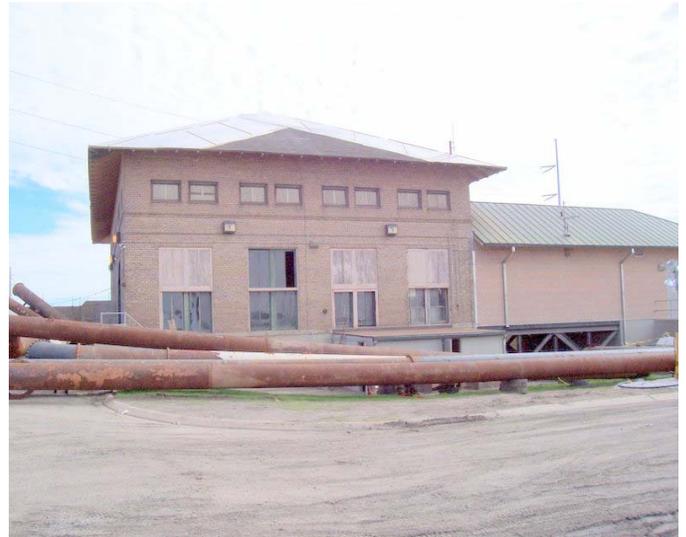
2. The pump room building roof, consisting of asphalt shingles, had considerable damage in the form of missing and broken shingles. It is recommended that the entire pump room roof be replaced. The electrical equipment room roof, a copper standing seam, was undamaged.

Photo 2 – Roof, soffit, and window damage.

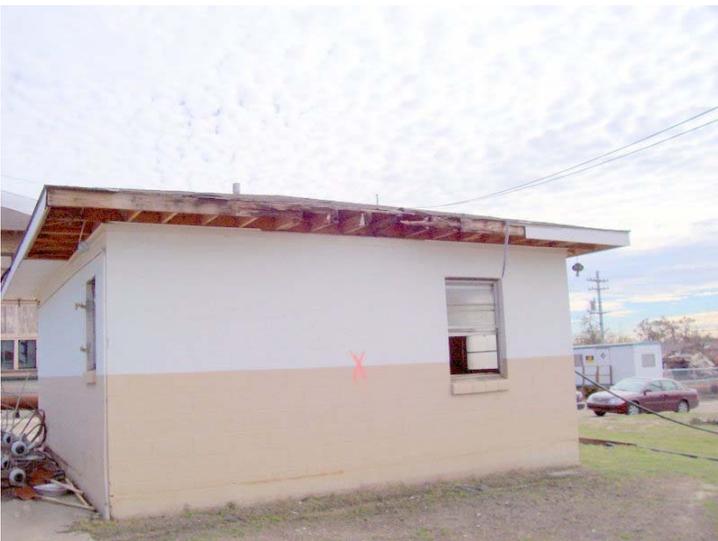
5. The oil storage building was completely submerged. The interior of the building is full of spilled oil, and should be completely cleaned out. The wood frame roof was damaged, and should be reconstructed. This includes the roof shingles, fascia, plywood soffits, and (2) exterior light fixtures. The windows were broken, and should be replaced.

Photo 3 – Damaged oil storage bldg.

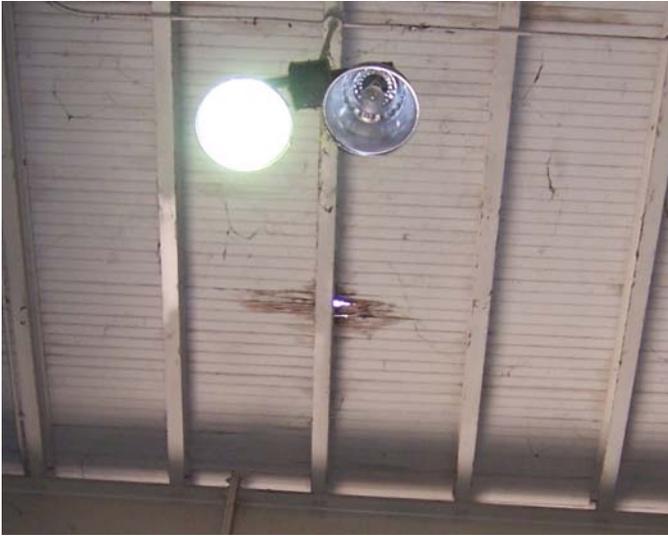
3. Pump Station Building Roof: Copper roof damage was evident from the east end of the building to Pump G, with two other isolated leaks near Pumps CD1 and V3. Approximately 200' X 48' of roof replacement is recommended.

Photo 1 – Damage to roof.

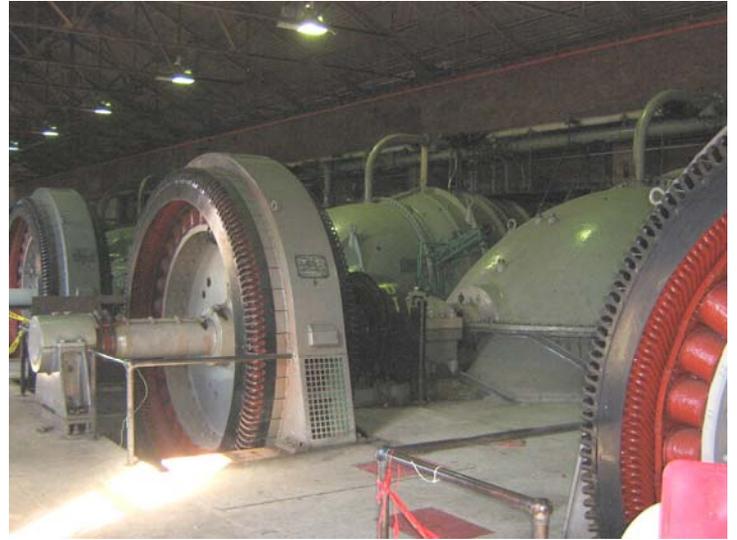
Photo 2 – 25 cycle pump motors to be rewound.

1. Pump motors for Pumps C, D, E and F were cleaned and baked. It is recommended that the motors for these 4 pumps have the stators and coils rewound due to having been submerged. (See Electrical description for Station No. 1) Motors for Pumps A and B are currently being rewound by the S&WB.

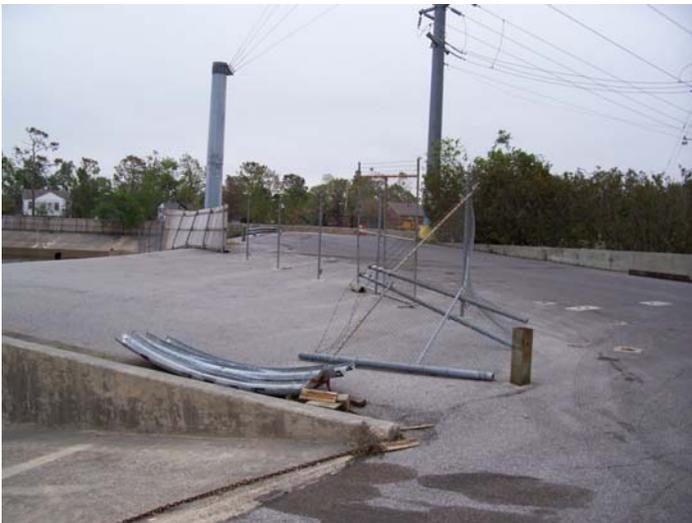
2. On the Maryland side of the station, a 36' X 10' wood gate with a metal frame was damaged, and 18' X 10' high wood fence was missing. On the Orpheum Street side of the station, a gate was missing and approximately 60' of 10' high wood fence was damaged or missing, and 60' of 10' high chain link fence was down. Eight 6"X6" wood bollards were sheared off. On the east side of the station approximately 150 LF of 10' high wood fence was damaged. Replacement is hereby recommended.

Photo 3 – Damaged fence on Maryland side.

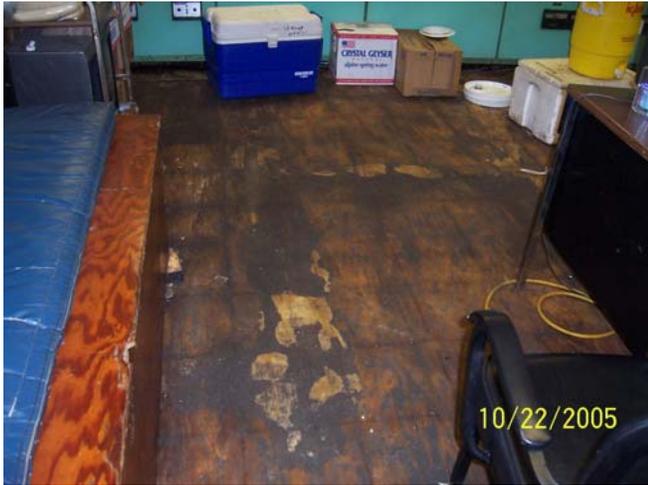
3. The 23'X24' control room wall paneling (inside and out), and vinyl floor tile and sub-floor were damaged and replacement is recommended.
4. A 10' X 10' chain link fence gate at the NW corner of the building was destroyed, as well a 30' section of 10' high chain link fence at the SW corner of the pumping station. Replacement is recommended.

Photo 1 – Missing tiles and damaged floor in room.

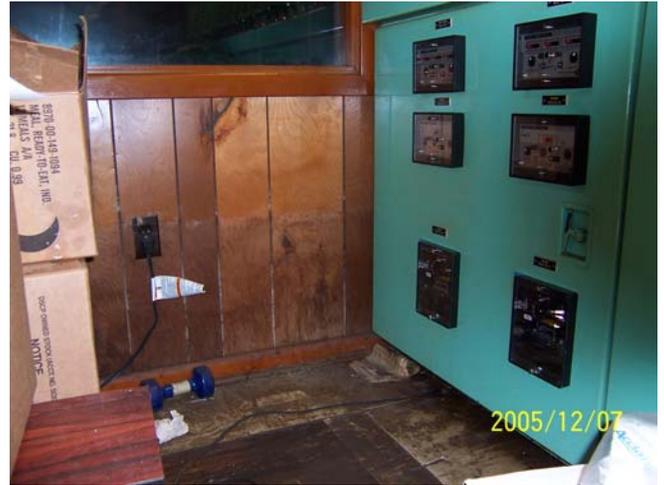
Photo 2 – Damage to walls in control room

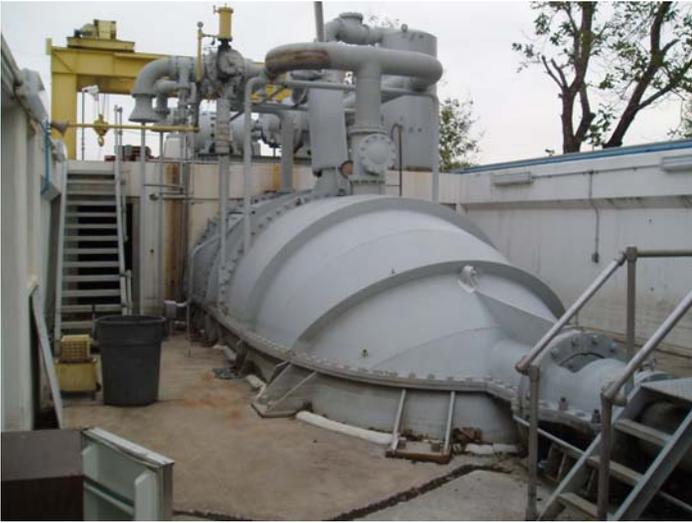
Photo 1 – Pump D

1. Open and inspect Pump D and repair or replace defective components.

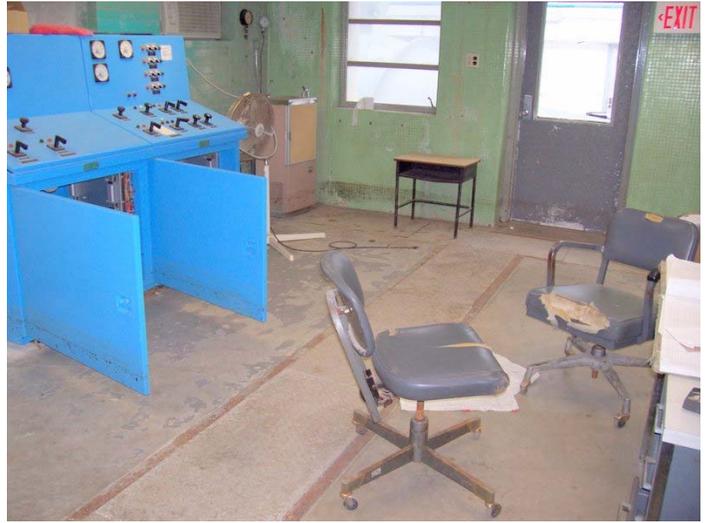
Photo 2 – Damaged tiles in control room.

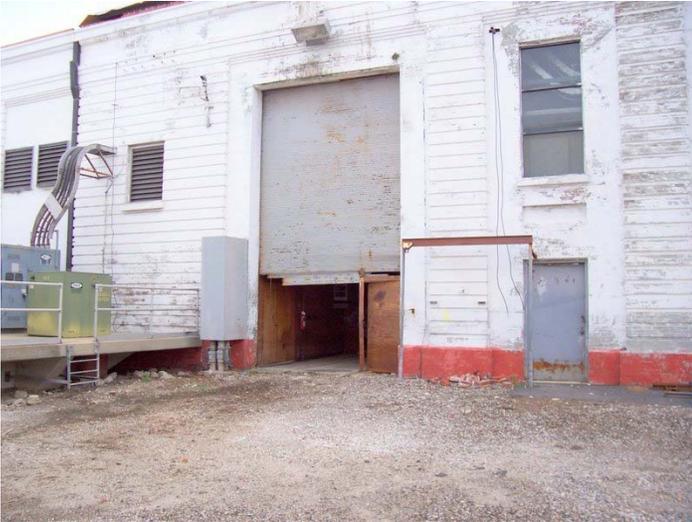
1. Flood water inside the building reached a height of about 2 feet inside the building.
2. Three rollup steel doors were damaged. Replace doors in kind.
3. Replace the tile floor and the paneling in the office and the bathroom due to these areas being submerged.
4. Repair leaking 48" St. Ferdinand discharge line at Claiborne Ave.
5. Repair damage to discharge end of 48" St. Ferdinand line at river due to wharf damage.

Photo 1 – Damaged roll-up door.

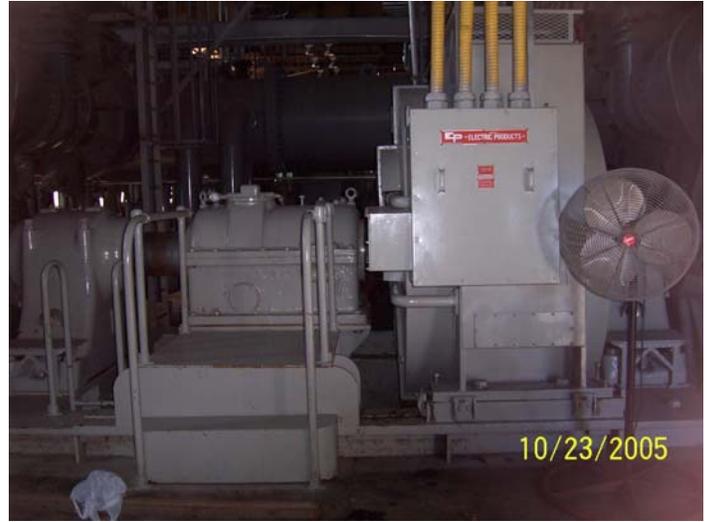
1. The motor for drainage Pumps A & D and the 4 motors for Frequency Changers #3 & 4 should be totally rewound due to having been submerged.
2. Replace all medium voltage switchgear (60 Hz) due to it being either submerged or flooded by rainwater.
3. Repair recorder that was flooded.

Photo 2 – Motor for drainage pumps A & D.

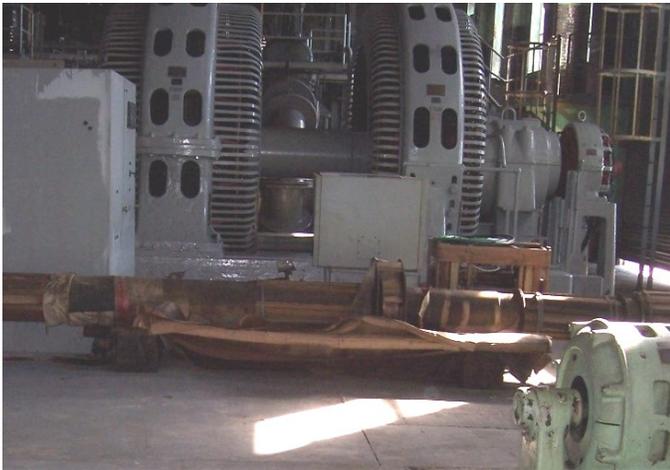
Photo 3 – Frequency changer motors.

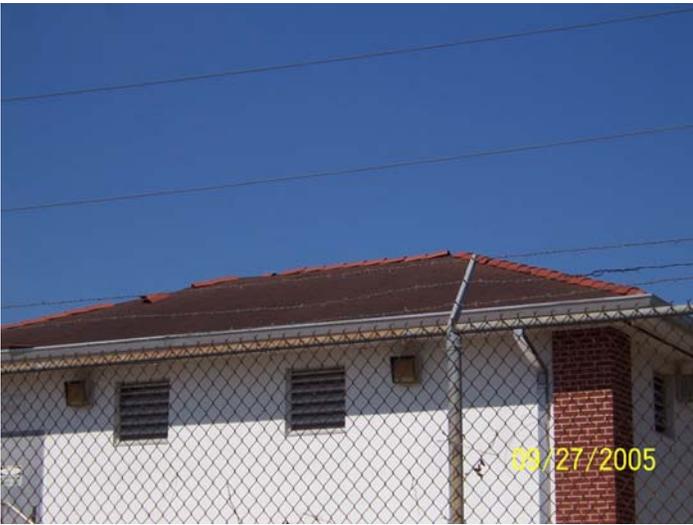
Photo 1 – Roof damage.

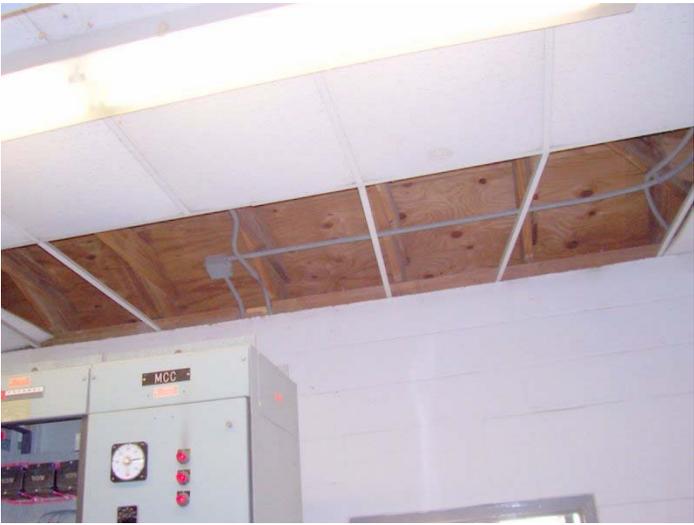
Photo 2 – Damaged ceiling tiles.

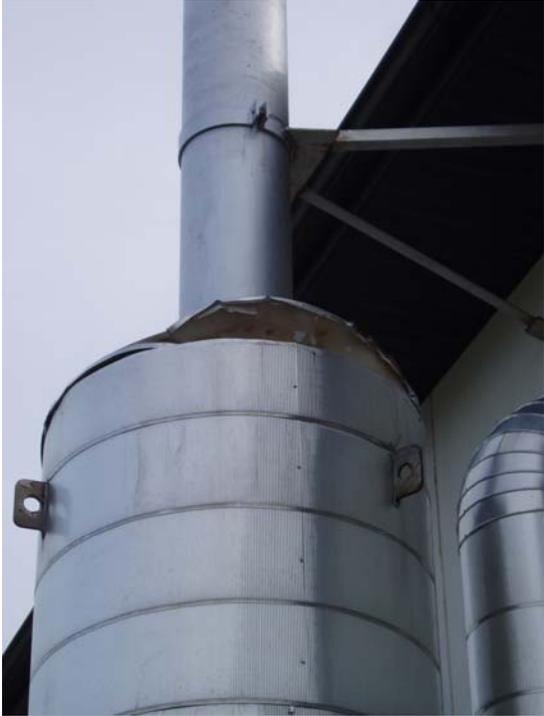
Photo 1 – Damaged generator muffler insulation.

1. Repair generator muffler insulation.

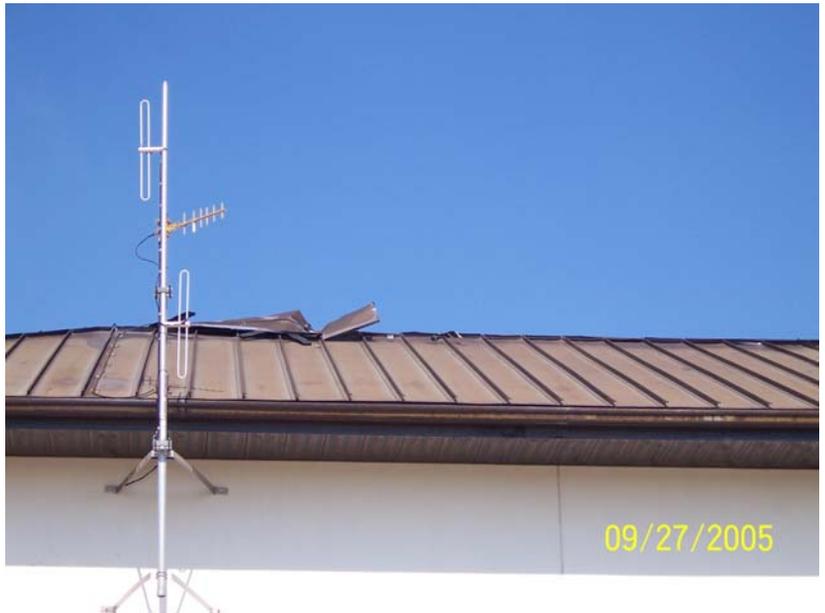
Photo 2 – Roof damage.

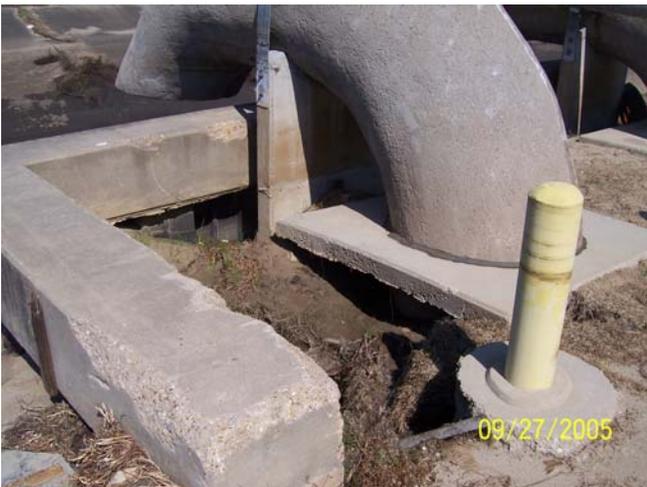
Photo 3 – Scour at discharge pipes.

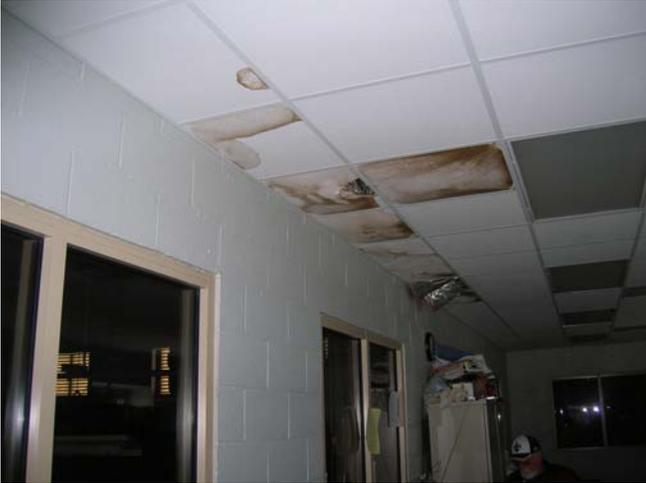
Photo 1 – Damaged ceiling tiles

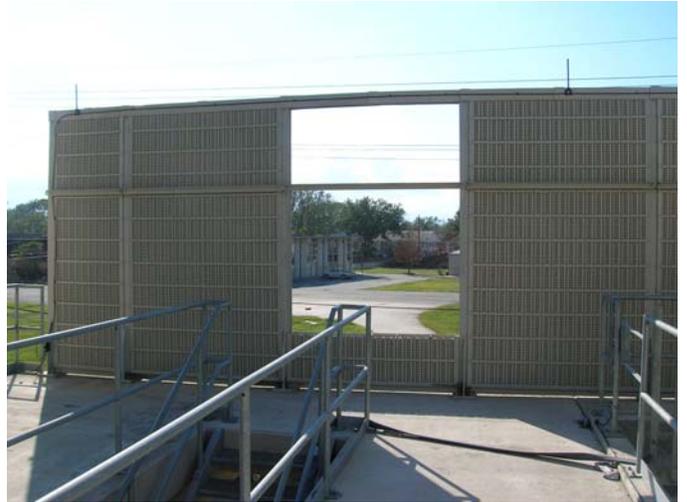
Photo 2 – Damaged noise reduction panel.

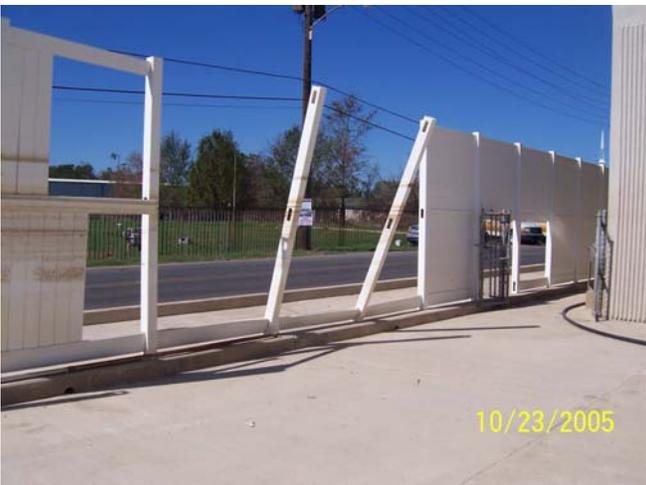
Photo 3 – Damaged vinyl fence.

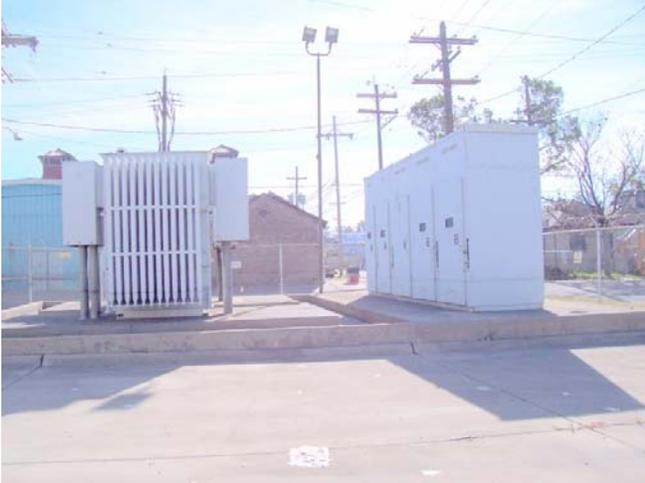
Photo 1 – Outdoor electrical equipment

1. Recommend that all 4 frequency changer motors be fully rewound due to having been submerged.
2. Rewire conductors in pits that were fully submerged.
3. Inspect, clean and repair damaged components of outdoor electrical equipment.
4. Replace battery rack and drip pan that are corroded due to salt water flooding

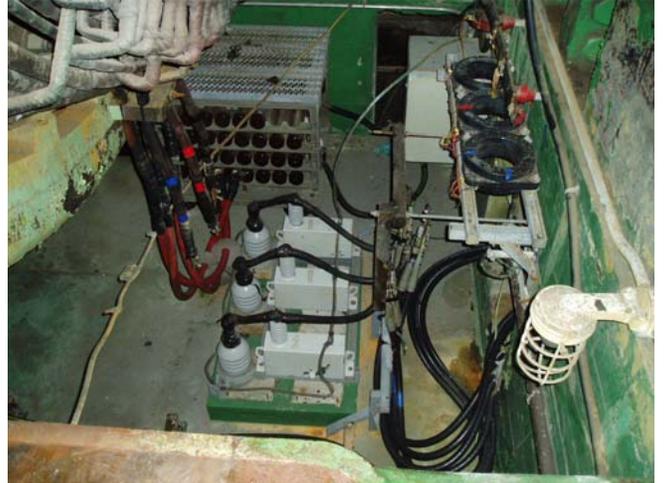
Photo 2 – Motor pit equipment

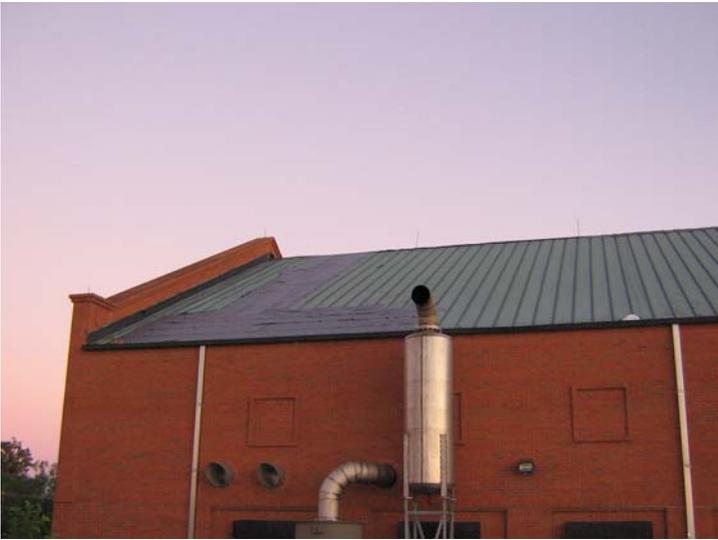
1. The flood water level in the station was confined to the basement area open to the intake side of the station. The operating floor was not flooded.
2. Approximately 4000 square feet of metal roofing was damaged. Repair is recommended
3. In the control room area approximately 10' X10' acoustical ceiling tile showed stains as a result of the station roof leaking. Replacement is recommended.

Photo 1 – Damaged roof

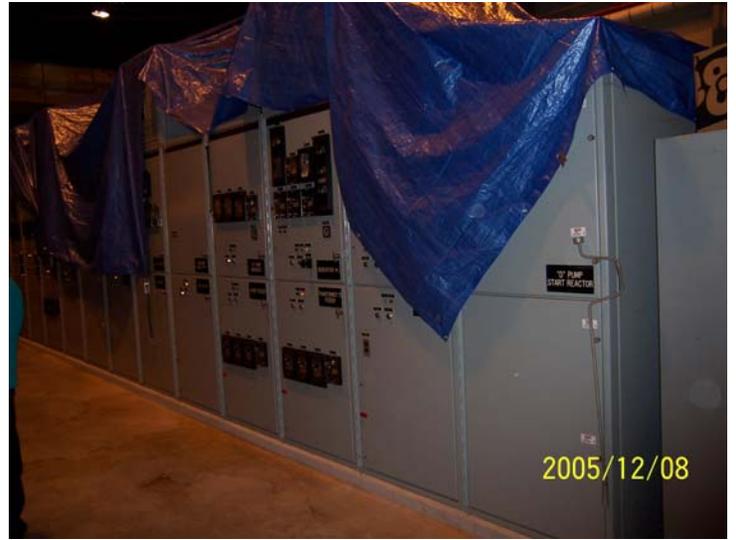
Photo 2 – Inspect switchgear

1. Inspect switchgear and motor control centers' internal components and replace damaged components as required.

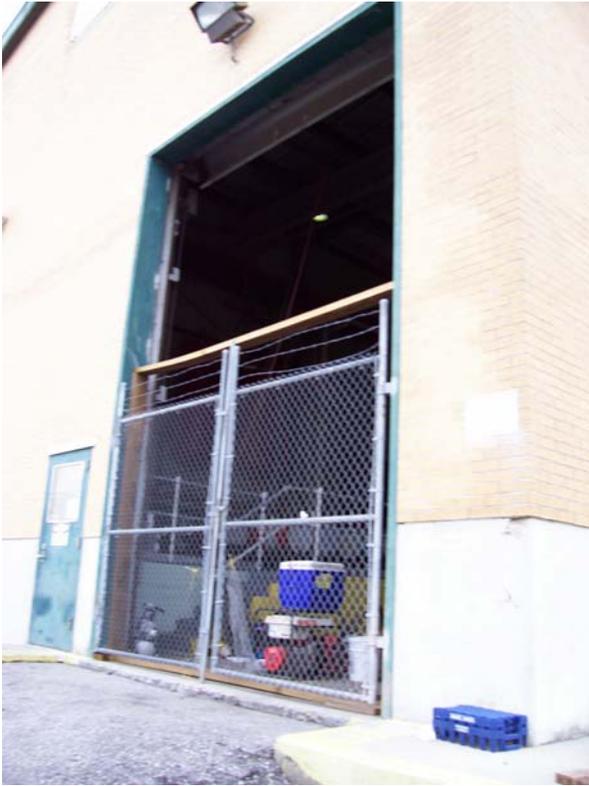
Photo 1 – Missing roll-up door

7. Recommend repair of a 12' X 19' steel roll-up door at the north end of the building, which blew out.
8. Eight 44" X 48" screen openings in the wall of the building were damaged. Recommend replacement.
9. Two sixty-inch air intake pipes blew off on the discharge side of the station. Recommend replacement.
10. Four 6" insulated meter vent stacks were blown off. Recommend replacement.
11. Both the inside and outside gantry cranes cable units were damaged. Recommend repairs.

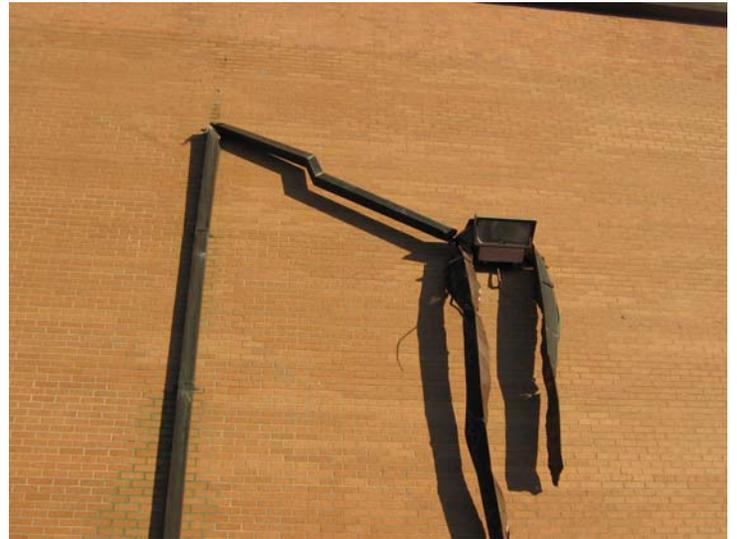
Photo 2 – Damaged downspout

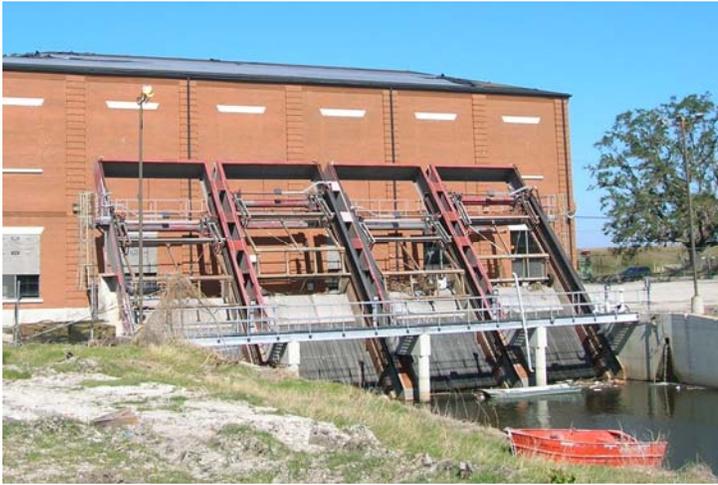
Photo 1 – Screen cleaner motors require replacement.

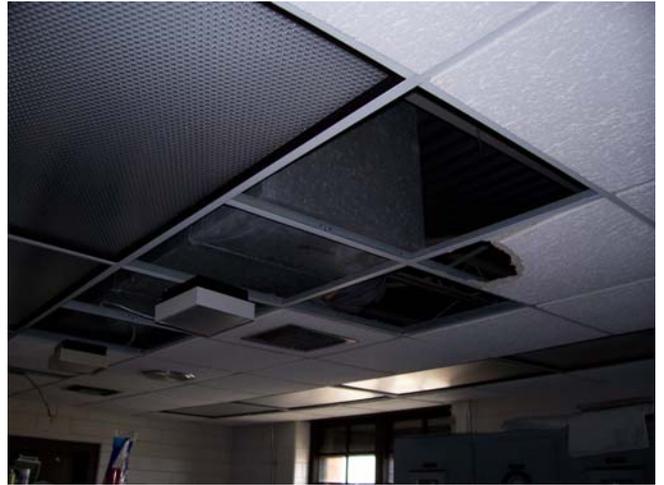
Photo 2 – Damaged ceiling tiles.

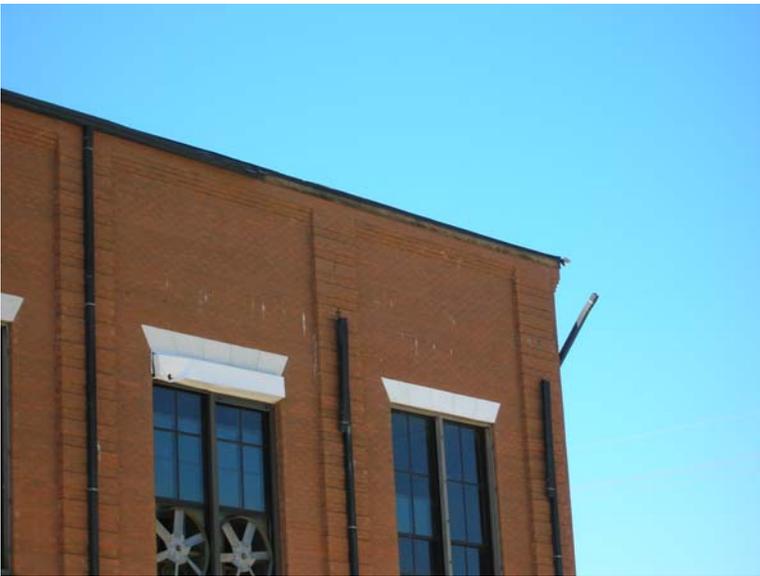
Photo 3 – Damaged gutter and downspout.

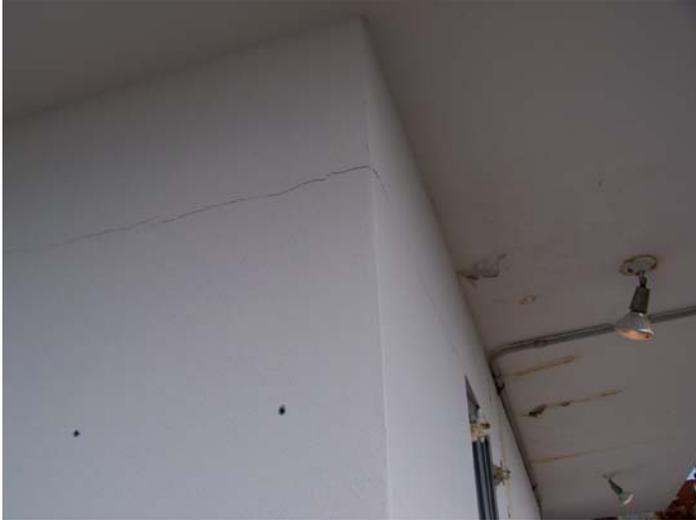
Photo 1 – Wall crack below roof overhang.

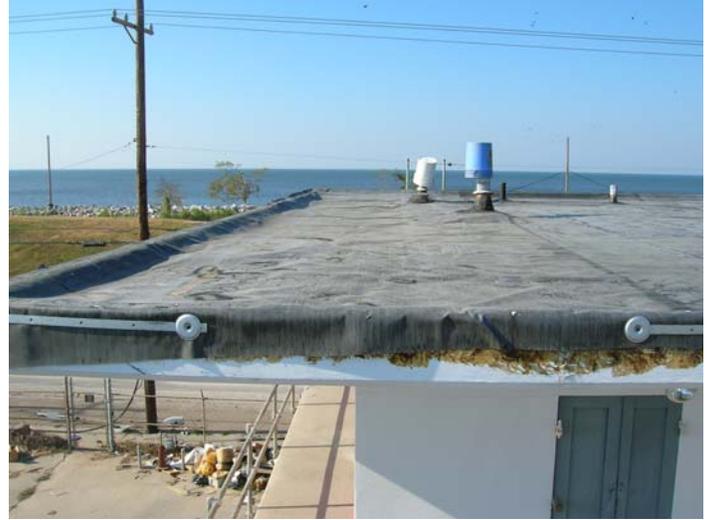
Photo 2 – Roof damage.

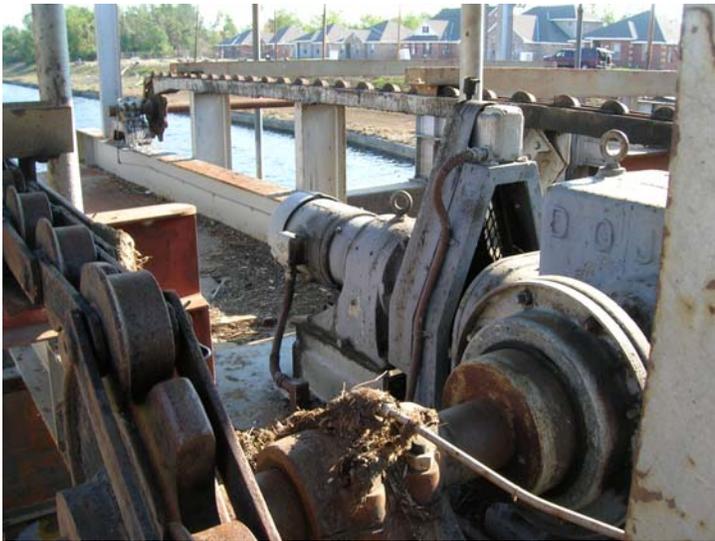
Photo 3 – Screen cleaner motors require replacement.

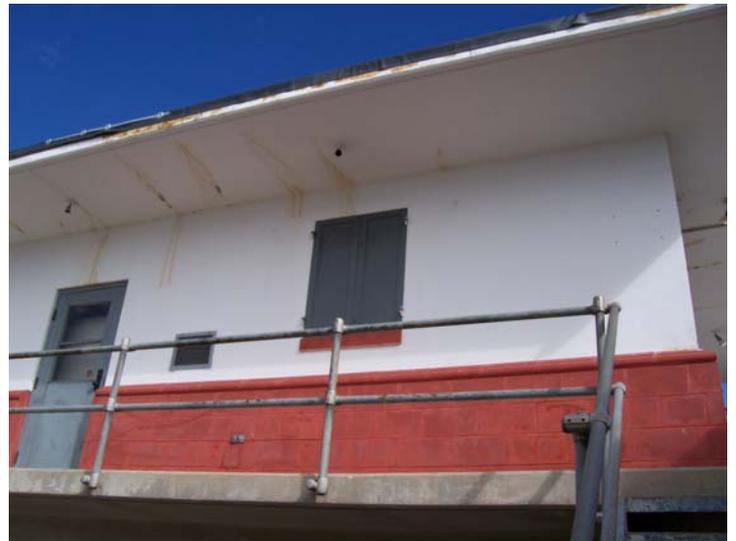
Photo 4 – Roof overhang.

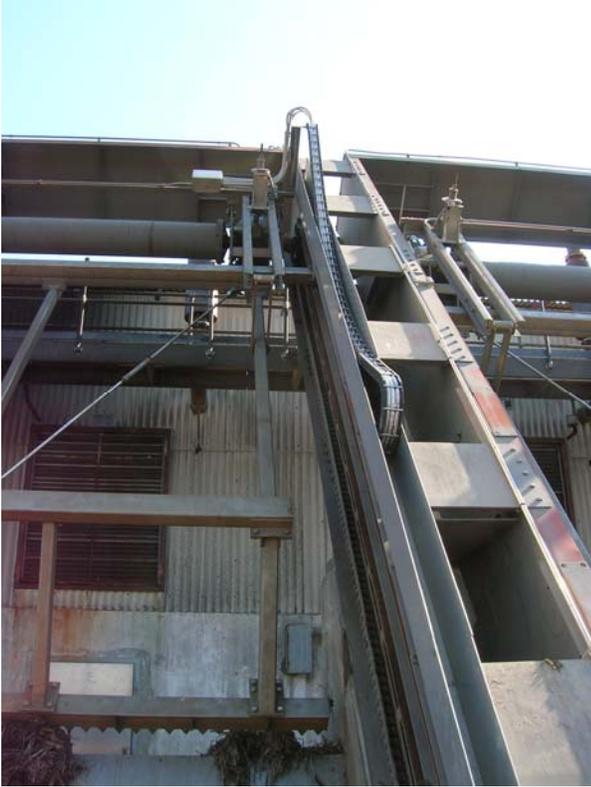
Photo 1 – Damaged trash rake cable tray

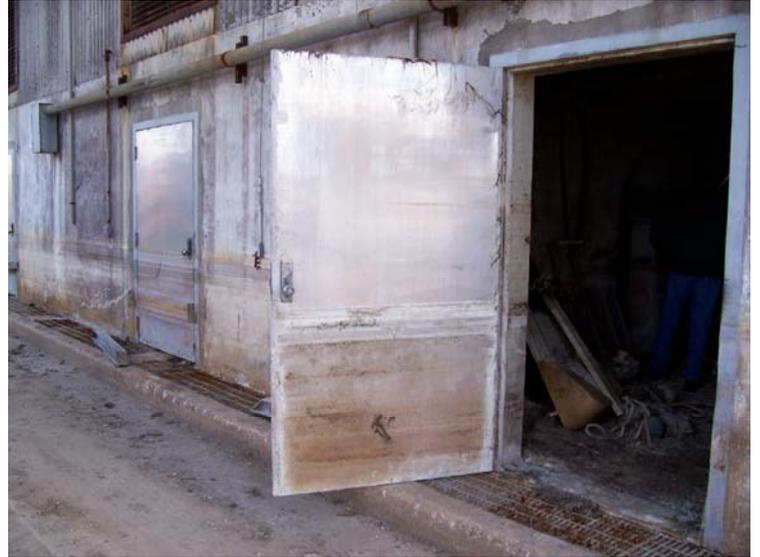
1. The flood water level was approximately 2 feet below the operating floor level.
2. Three 4' X 7' steel doors on the basement level are corroded through. Replacement is recommended.
3. Replacement of 100 LF of 6' high, barbed wire topped fence and gates, which are missing on the east side of the station is recommended.
4. Replacement of 80 LF of galvanized steel hand railing, which is damaged along the cat walk at the trash rack is recommended.
5. The ladder leading to the roof is bent out of shape. Repair is recommended.
6. Replacement of two 12" diameter roof vents, which blew off, is recommended.
8. Replace two damaged trash rake support struts, approximately 40 LF each.

Photo 2 – Damaged steel doors

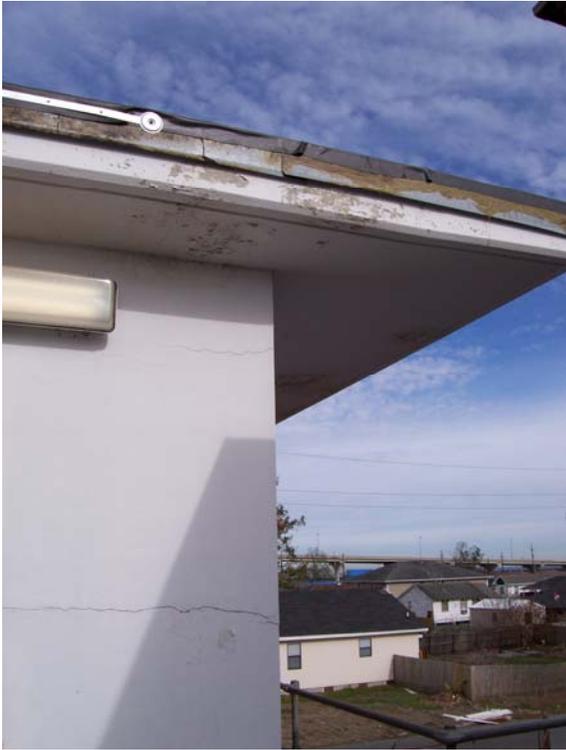
Photo 1 – Crack in bldg. wall

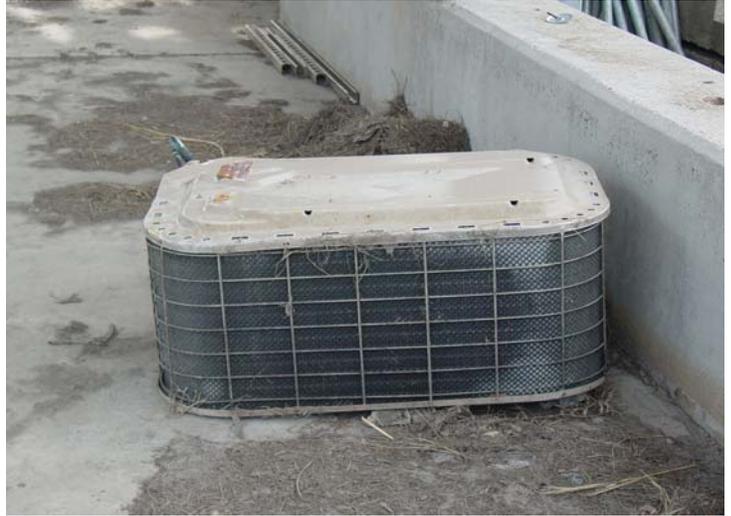
Photo 2 – Damaged air conditioner

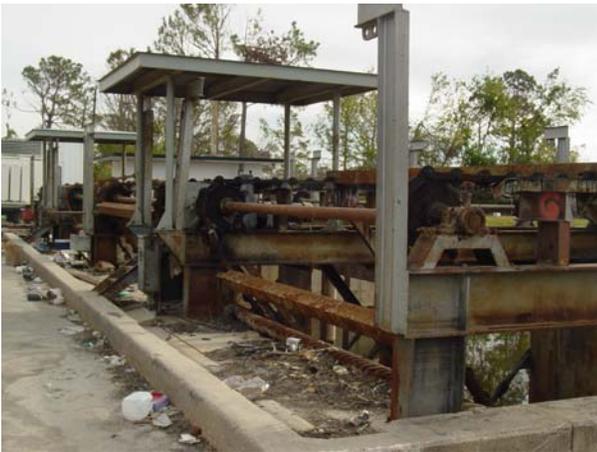
Photo 3 – Damaged trash rakes.

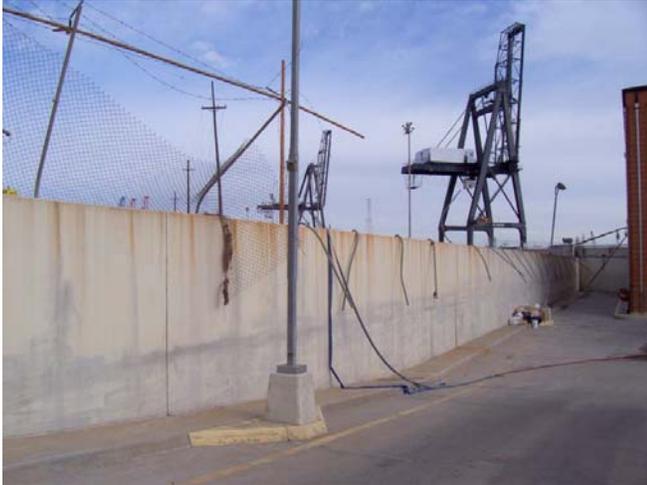
Photo 1 – Damaged fence on west wall
